TECHNICAL REPORT  
NATICK/TR-85/026

# TRAY PACK IMPROVED DURABILITY PACKAGING ROUGH HANDLING TEST RESULTS

RICHARD D. CUMMINGS

UNITED STATES ARMY NATICK  
RESEARCH AND DEVELOPMENT CENTER  
NATICK, MASSACHUSETTS 01760-5000  
FOOD ENGINEERING LABORATORY

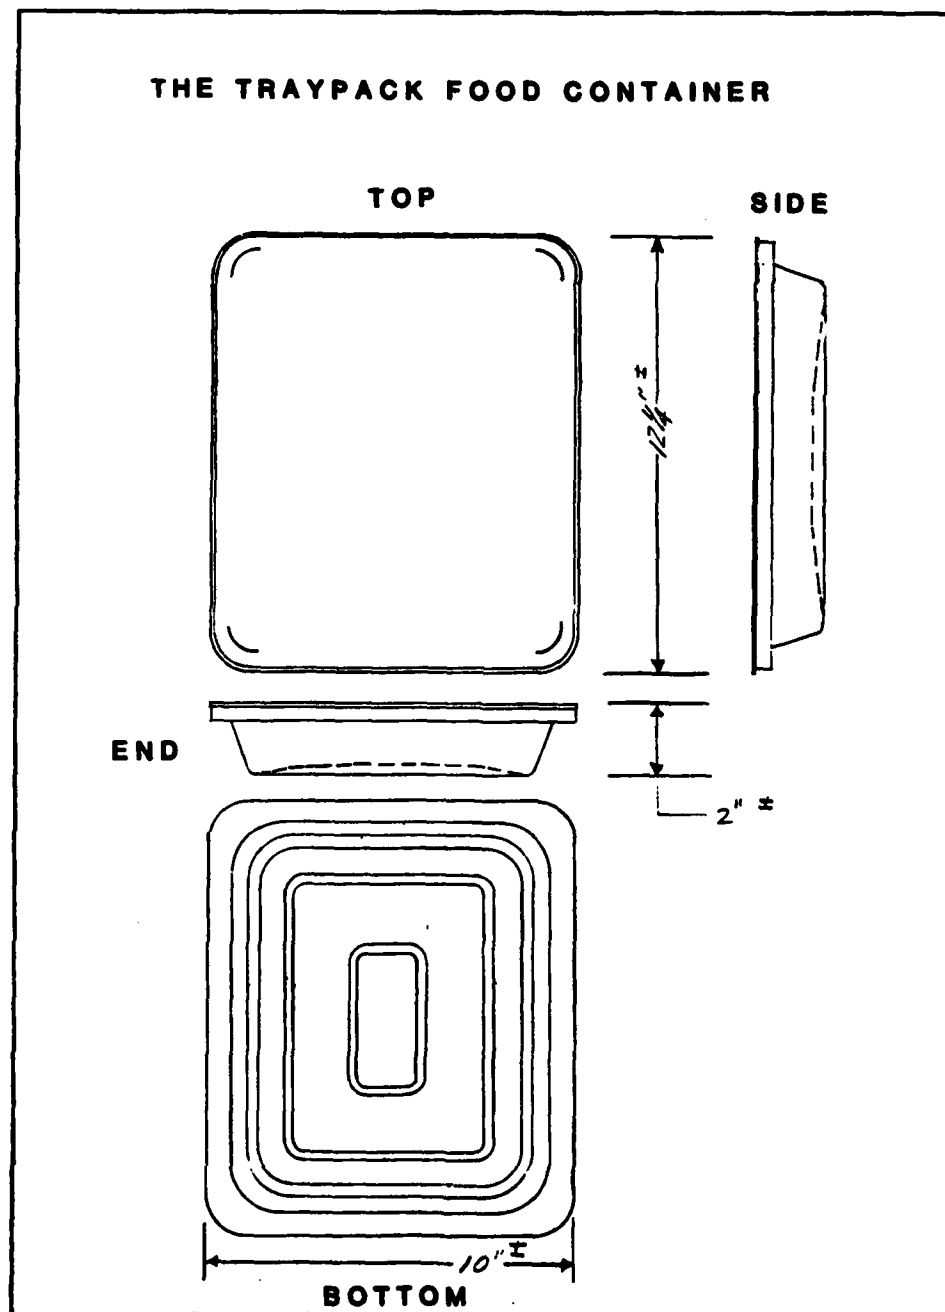
Figure 1. The Tray Pack food container

The top or lid is drawn from 85-pound (0.0094-inch-thick) steel. The lid material has an inner polymeric liner to prevent food contamination and an exterior coating to retard corrosion and oxidation. The lid is nearly flat across its entire surface.

The bottom or can is drawn from 75-pound (0.0083-inch thick) steel. The bottom also has a polymeric inner liner and an outer metal coating. The drawing process on the bottom results in numerous material excesses and these are drawn into a regular pattern by means of vertically oriented indentations and bulges of approximately 0.070" depth around the perimeter of the can. Around the corners these indentations and bulges are sinusoidal in cross

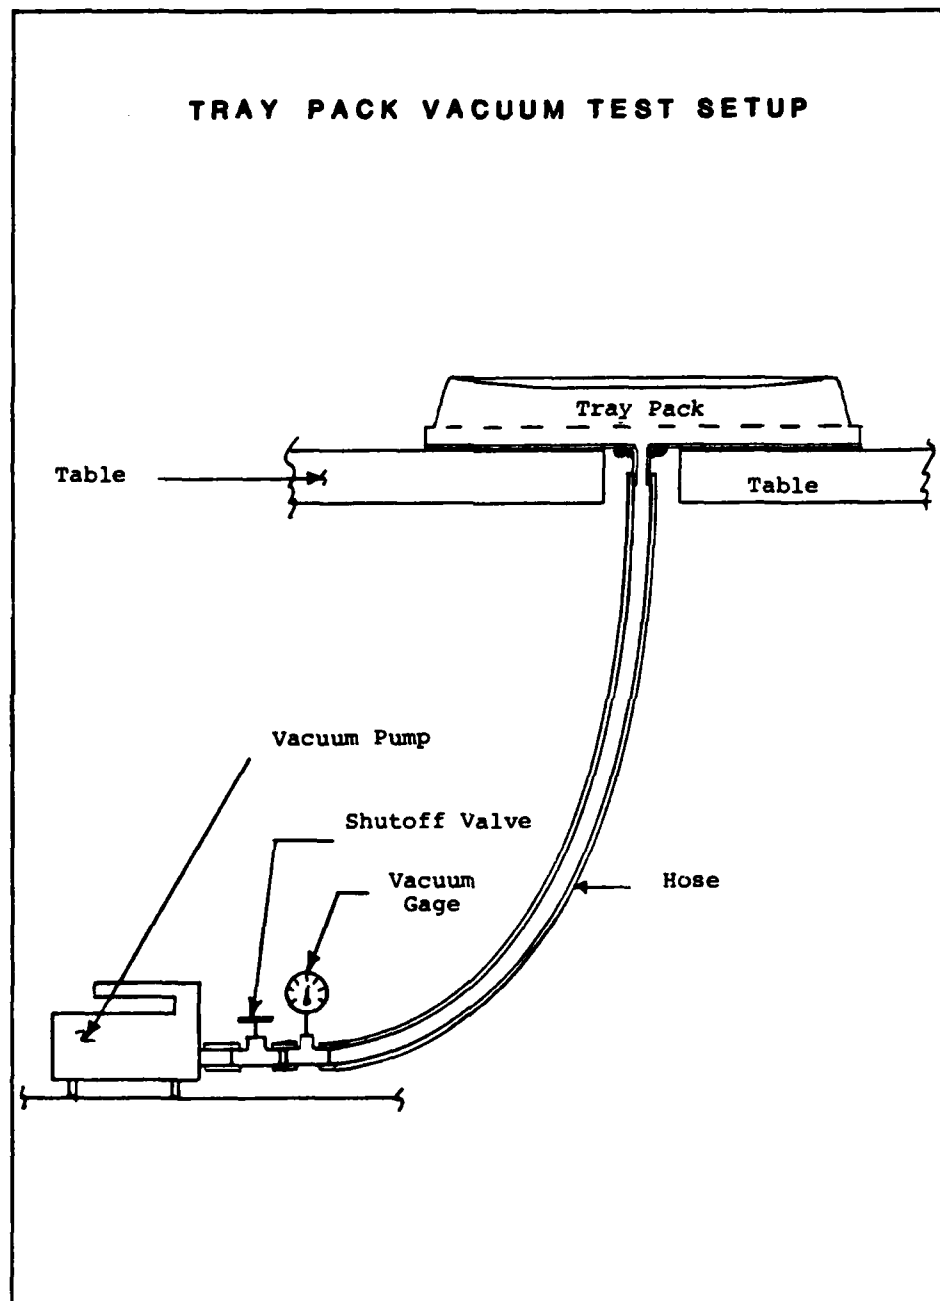
Figure 5. Tray Pack vacuum test setup

Early in our testing we determined that dropping the Tray Pack on its side resulted in paneling and buckling of the Tray Pack bottom and lid. We hypothesized and theorized that this damage was caused by hydrodynamic forces within the Tray Pack fluid applied to the container surfaces; a positive pressure on the lid near the impact side caused buckling and a negative pressure on the bottom opposite the impact side caused paneling.

In order to ascertain the level of pressure required, we formulated the vacuum evaluation test shown in Figure 5. In this test we created a vacuum in the Tray Pack and continued to increase the vacuum level until paneling failure occurred.

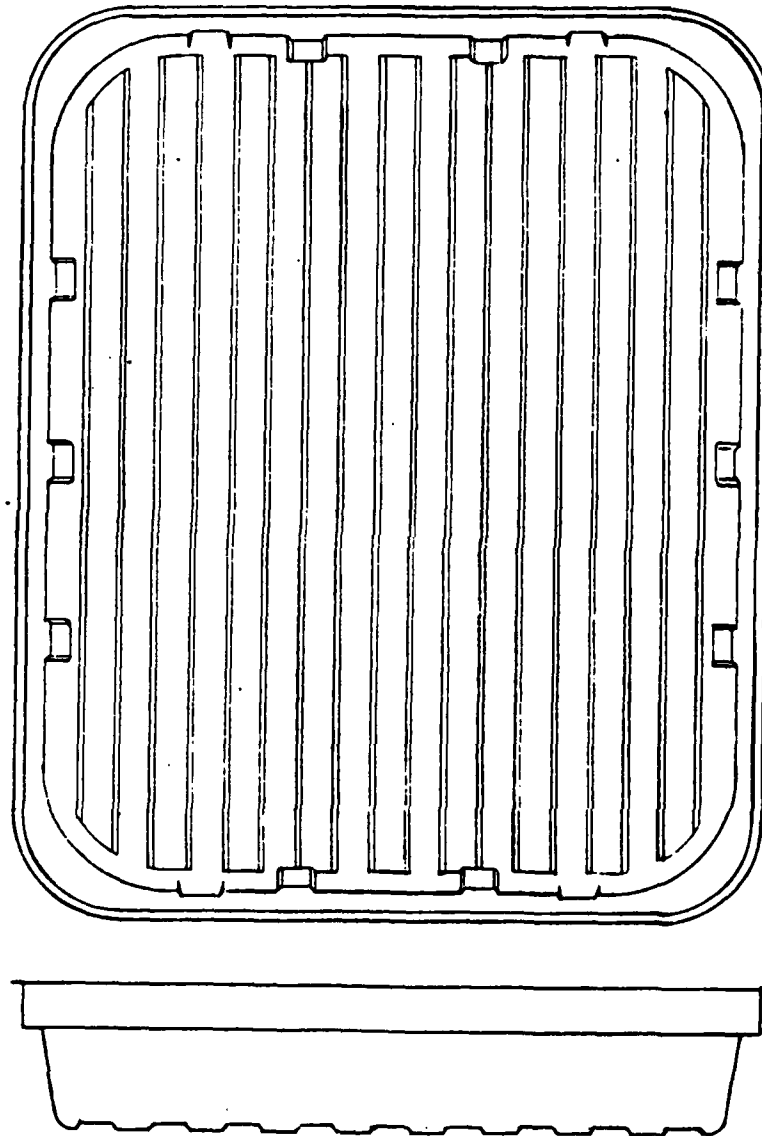
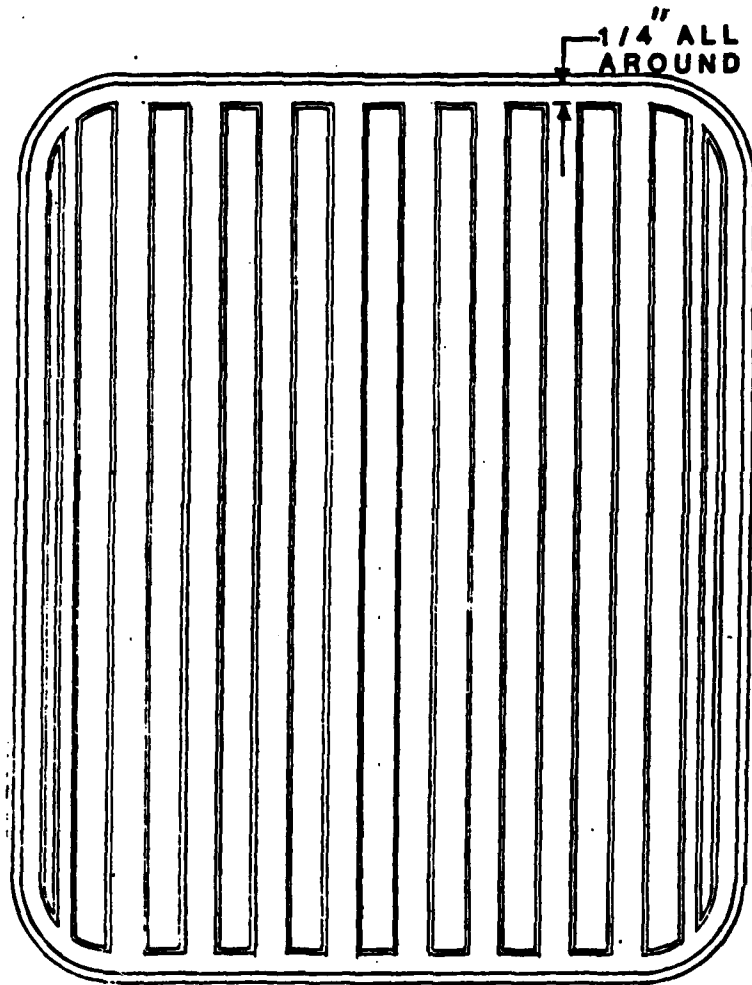
Figure 14a. Reinforced Tray Pack concept

This concept is shown in Figure 14.

Our test results indicate that the heavyweight reinforced Tray Pack will survive the rough handling transportation environment without damage. We recommend a further development program to manufacture and test production samples of this design.

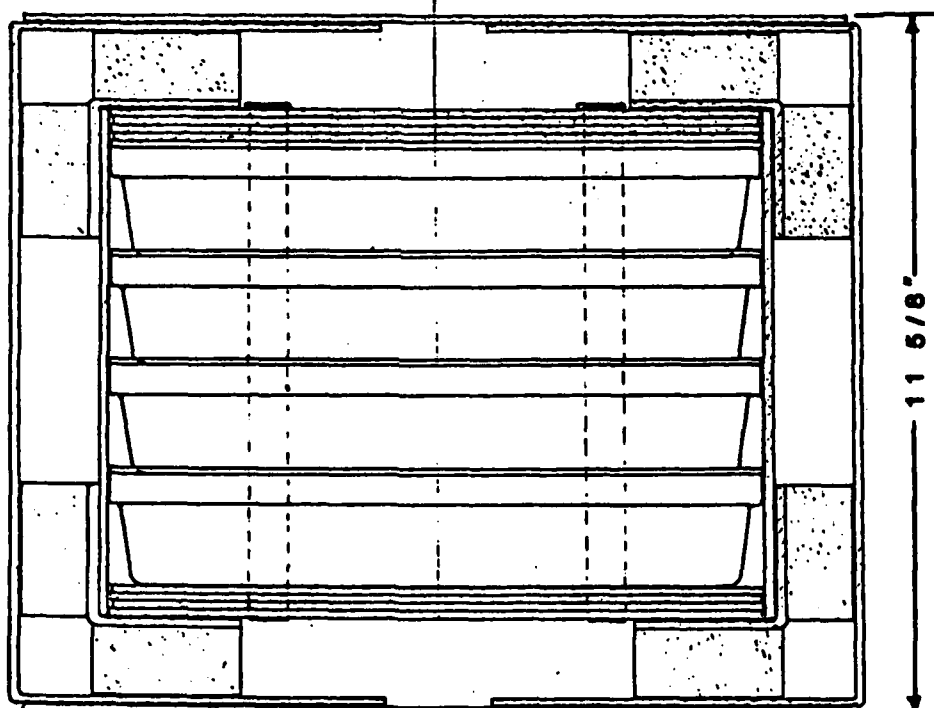
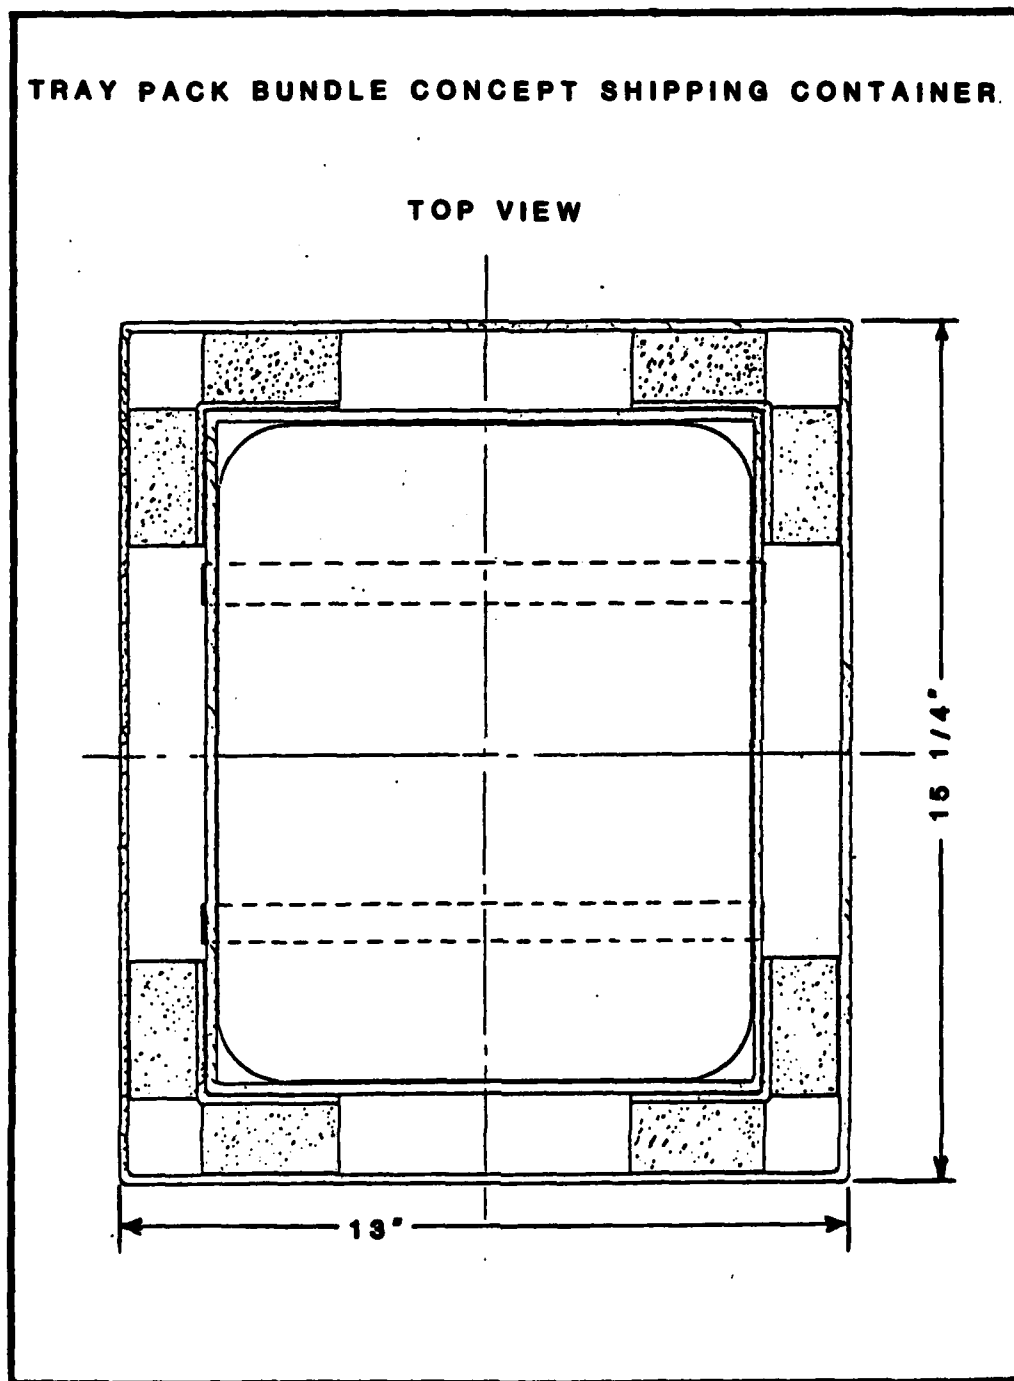
Figure 15a. Tray Pack bundle concept shipping container

The bundle concept, shown in Figure 15, performed quite well under evaluation testing and was therefore included in our Acceptance Testing Program. As can be seen from Figure 15, this concept requires more parts and a larger box than the baseline shipping container concept. Consequently, its cost is greater as shown in Table 14. The cost is increased per filled Tray Pack by 8.3%

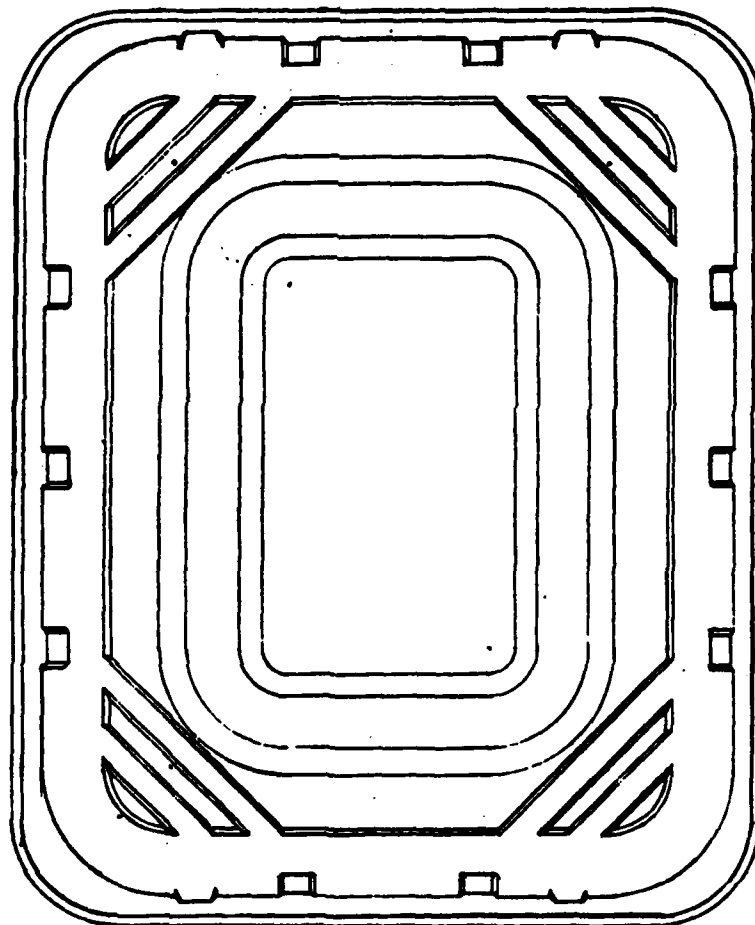
**Figure 19. Cross reinforced Tray Pack**

Table 17 is a summary of the prefailure vacuum levels achieved by each of the sample types tested. The sample concepts are depicted in Figures 18, 19, 20, 21. Each succeeding concept represents a greater degree of reinforcement. Each succeeding concept also is capable of withstanding a greater degree of vacuum. The last two concepts incurred panels which developed quite slowly, in a very controlled manner, as opposed to the instantaneous change incurred by the first two concepts indicating that the paneling is induced by means of a different mechanism.
